AMERICAN UNIVERSITY

Transportation Existing Conditions Assessment for 2011 Master Plan Update

GOROVE/SLADE ASSOCIATES, INC.
Transportation Planners and Engineers

July 2009

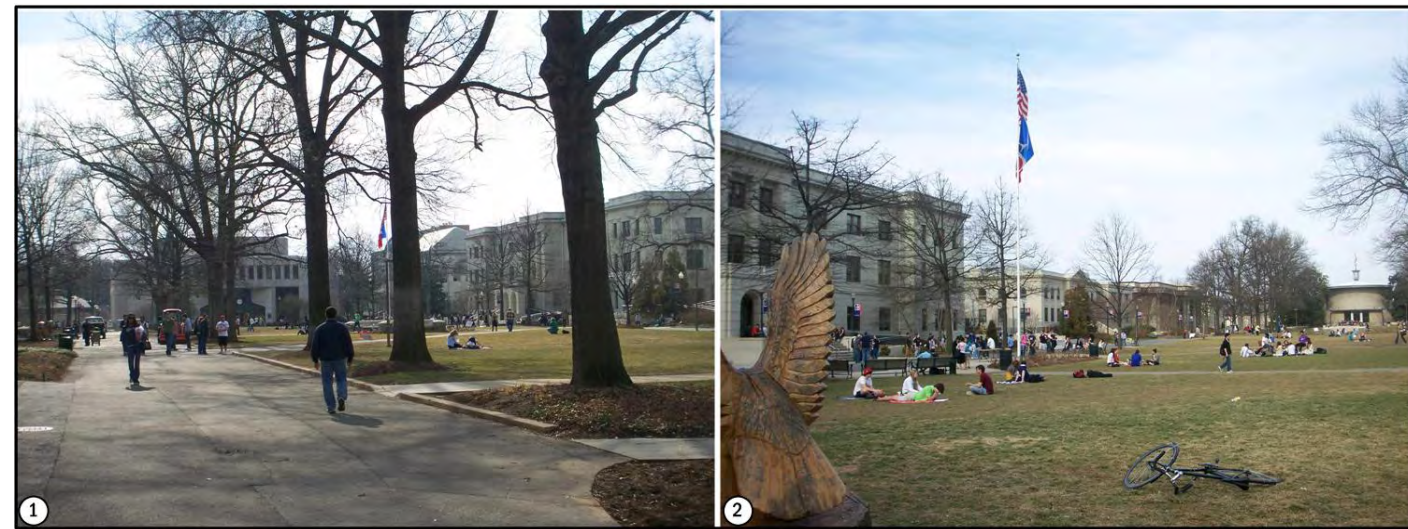
Photo 1: Eric Frieheim Quadrangle

the steps of an academic building. Photo 1 captures conditions in the quad on such a day.

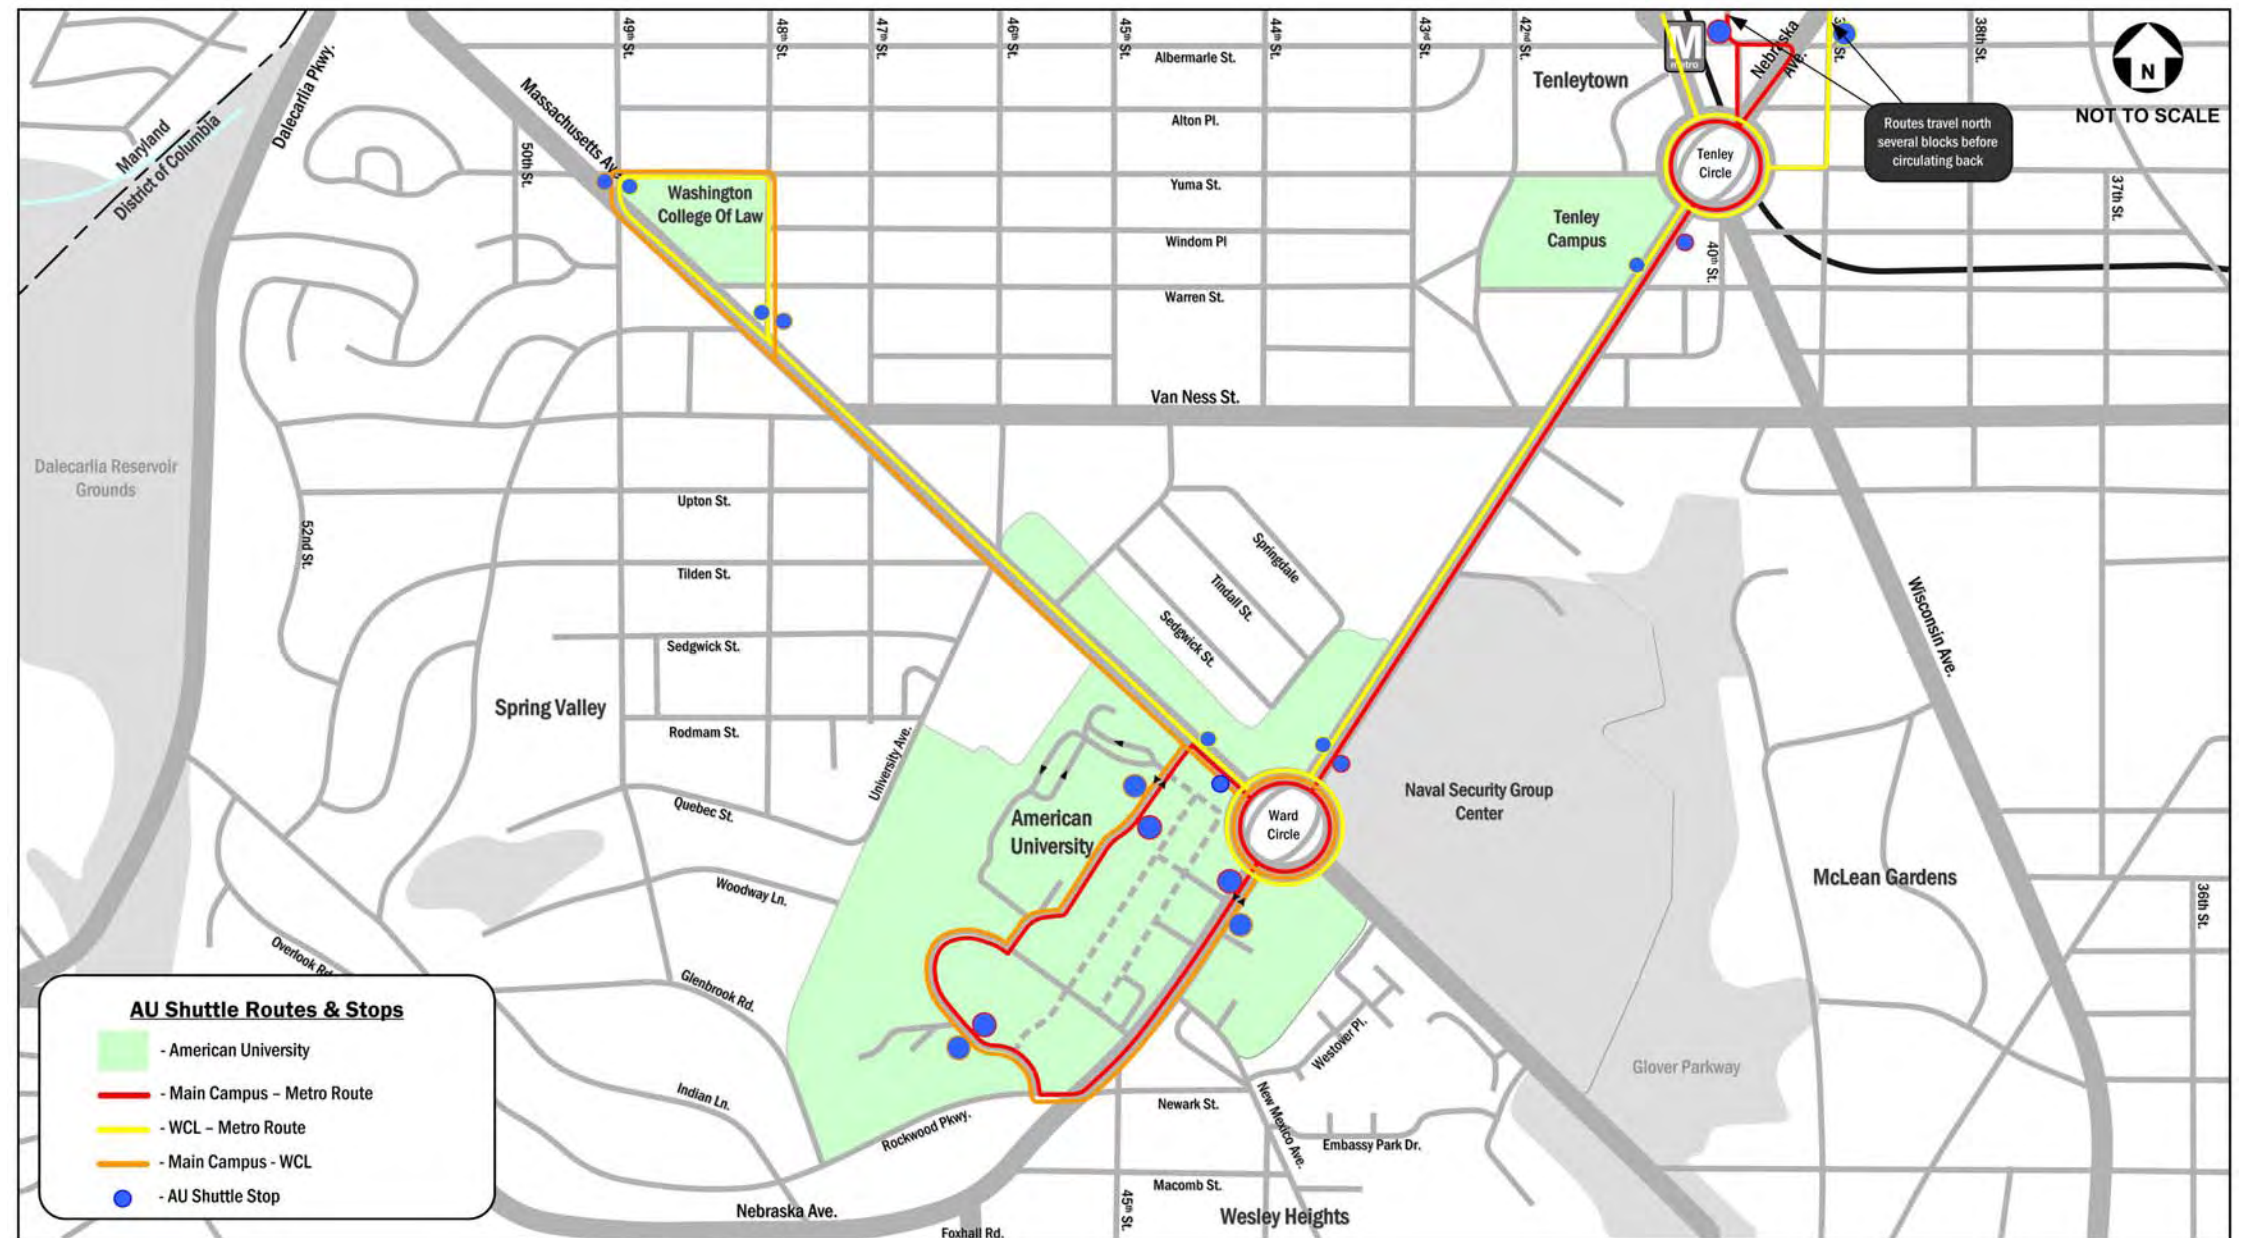
Photo 3: AU Shuttle Stops On-Campus

These stops are major sources of pedestrian traffic and high volumes of passengers waiting, boarding and alighting. The on-campus routes and stops are well located because they separate vehicle routes and pedestrian routes, which limit conflicts. Photo 3 captures conditions at these shuttle stops.

A review of shuttle conditions found no major areas of concern but improvements to shuttle routes and stops are possible. Stop improvements include adding amenities such as shelter, seating, and route information. Intelligent Transportation Systems (ITS) could be implemented to enhance shuttle service. For example, shuttle stops could provide information on the time remaining until the next bus arrives. This information could also be made available on the internet, which would help passengers plan their trip before departing for the shuttle stop. The number and routing of AU shuttle routes are another area of operation that may warrant further study to determine the most efficient routing and stop location given ridership trends and available resources. There is a substantial amount of overlap between the three routes, combining them in some fashion may help reduce operational costs and/or increase service frequency. Another possible improvement to the AU shuttle system would be the addition of bicycle racks to shuttle vehicles, to allow for better integration of the two modes.

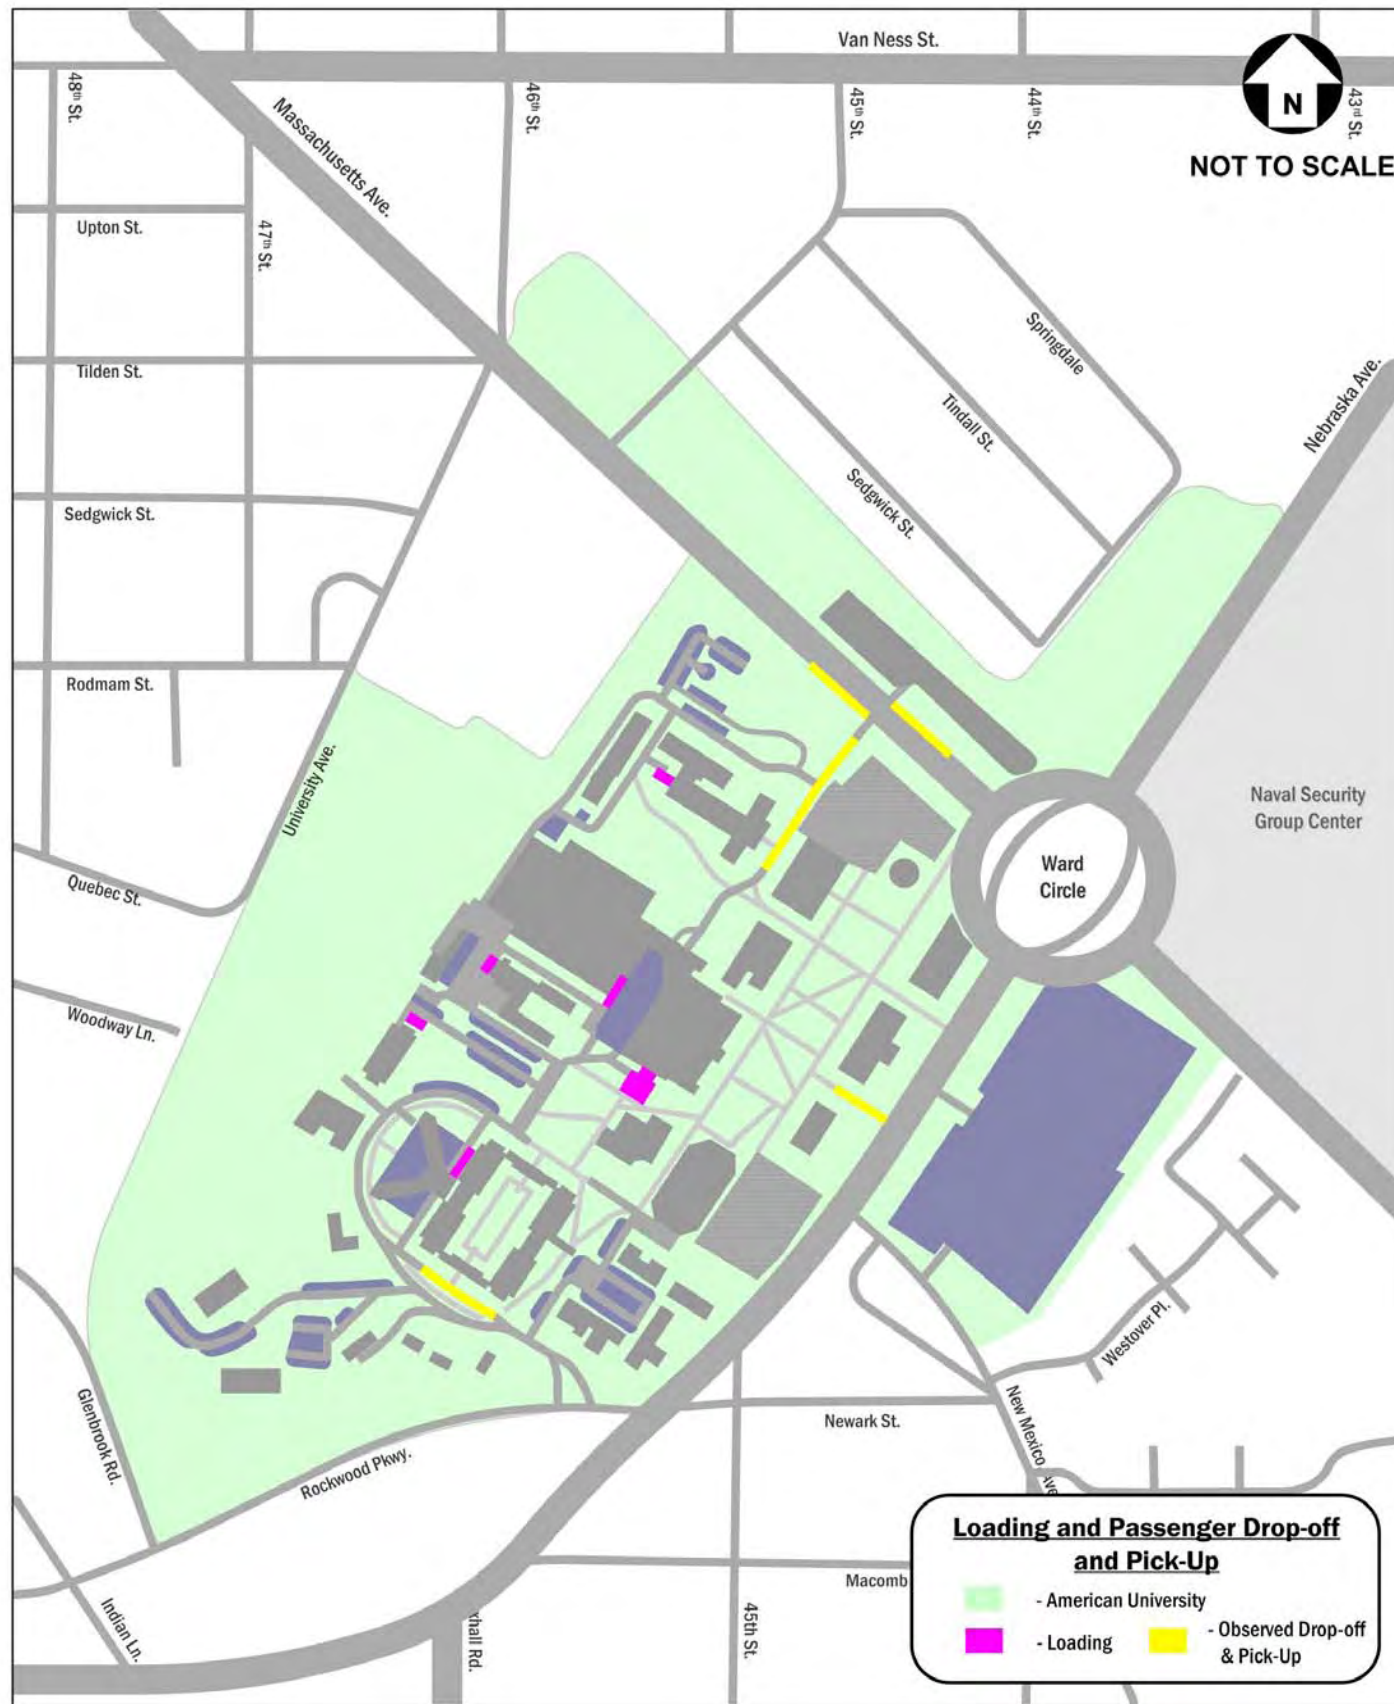
Figure 10: Loading & Pick-up/Drop-off Activity

Passenger drop-off and pick-up activity occurs throughout the campus. Figure 10 identifies the most commonly used locations for passenger drop-off and pick-up. There are no designated drop-off or pick-up locations on campus or areas where this activity is easily accommodated.

Shipping and receiving facilities are located throughout the campus. Figure 10 identifies the location of shipping and receiving facilities. These facilities and the vehicle ingress and egress routes do not cross or conflict primary pedestrian routes.

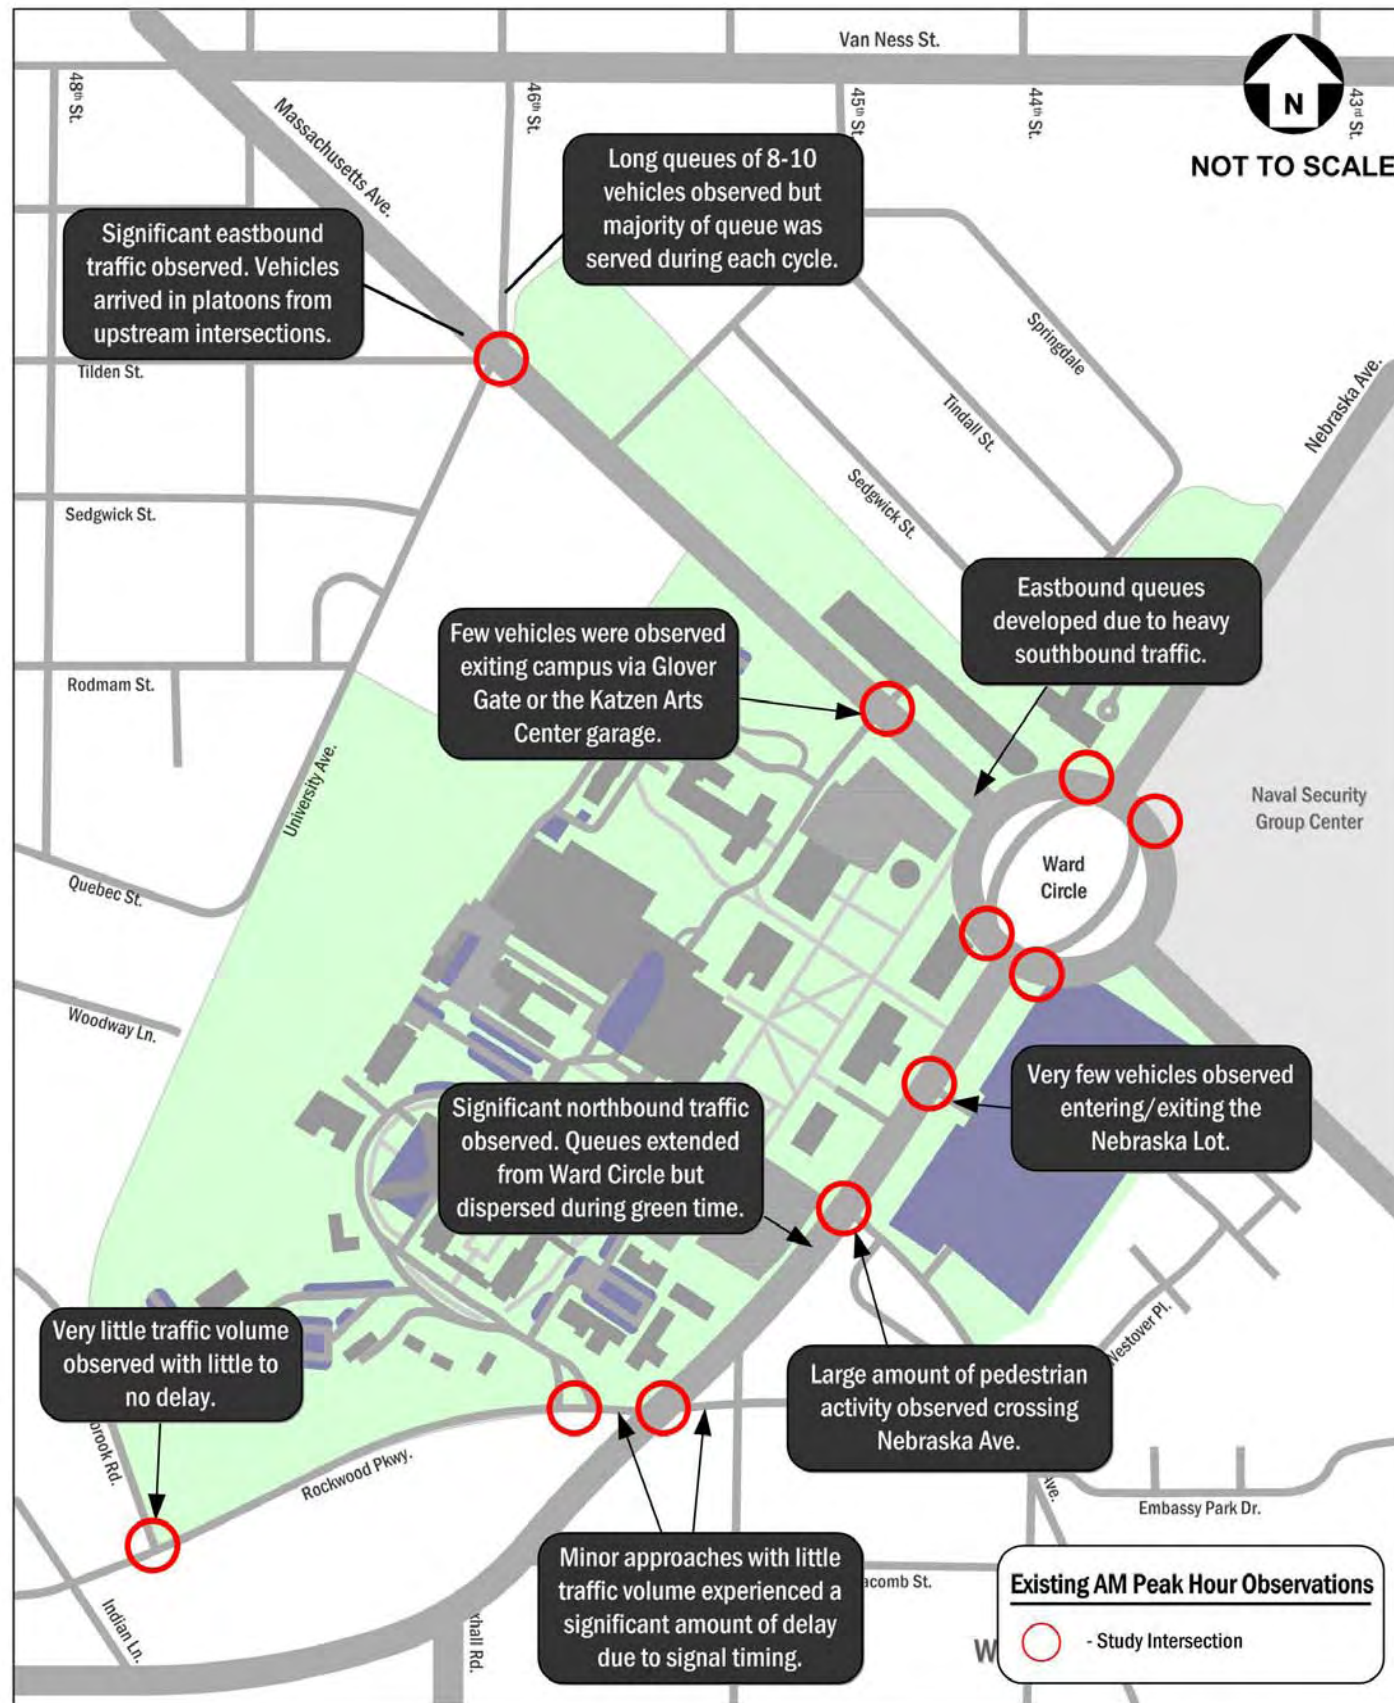
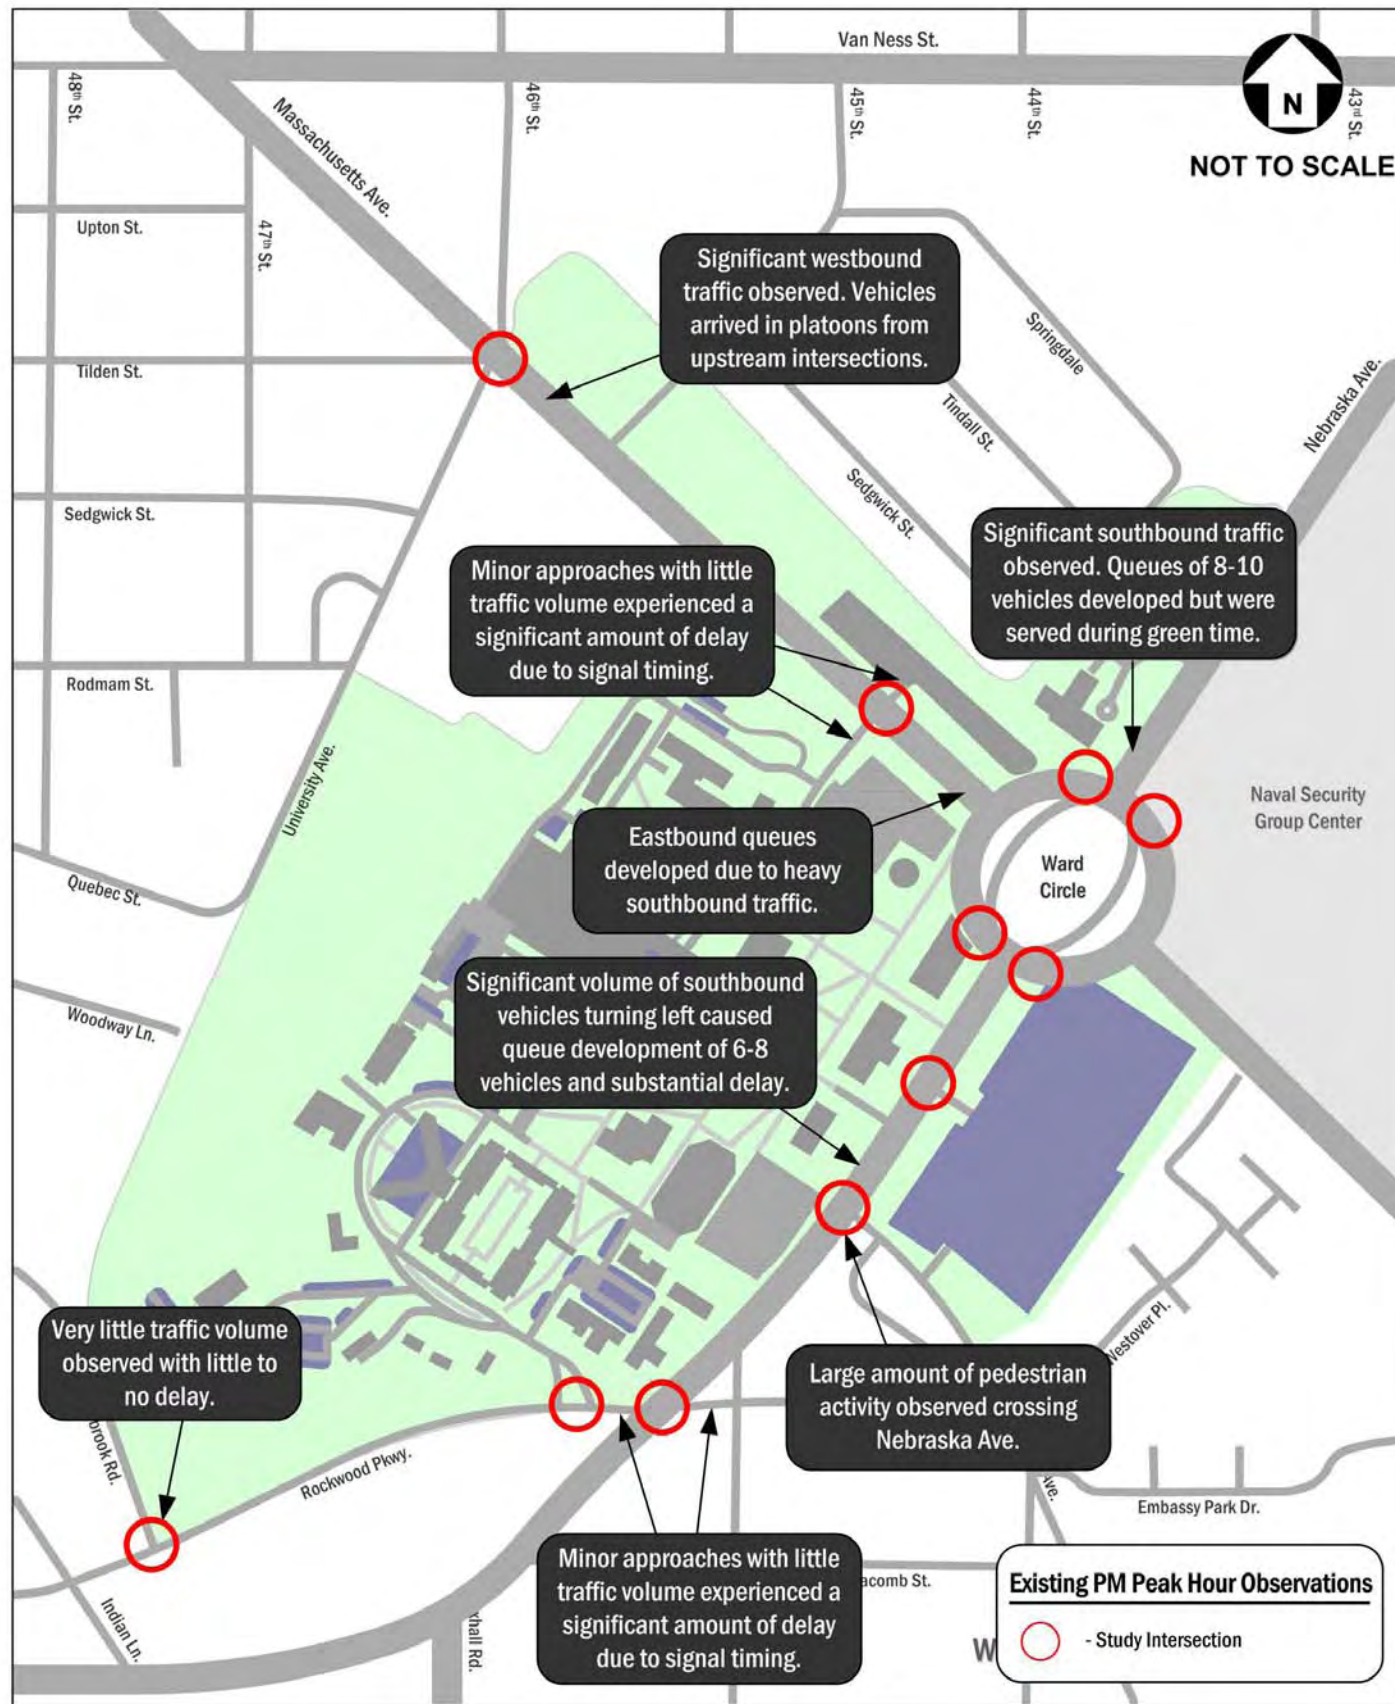
Figure 12: AM Peak Hour Observations

Morning and afternoon peak hour traffic observations were conducted at the study area intersections in order to determine traffic conditions near the AU main campus. Traffic observations are shown on Figure 12 and Figure 14 for the morning and afternoon peak hours, respectively.

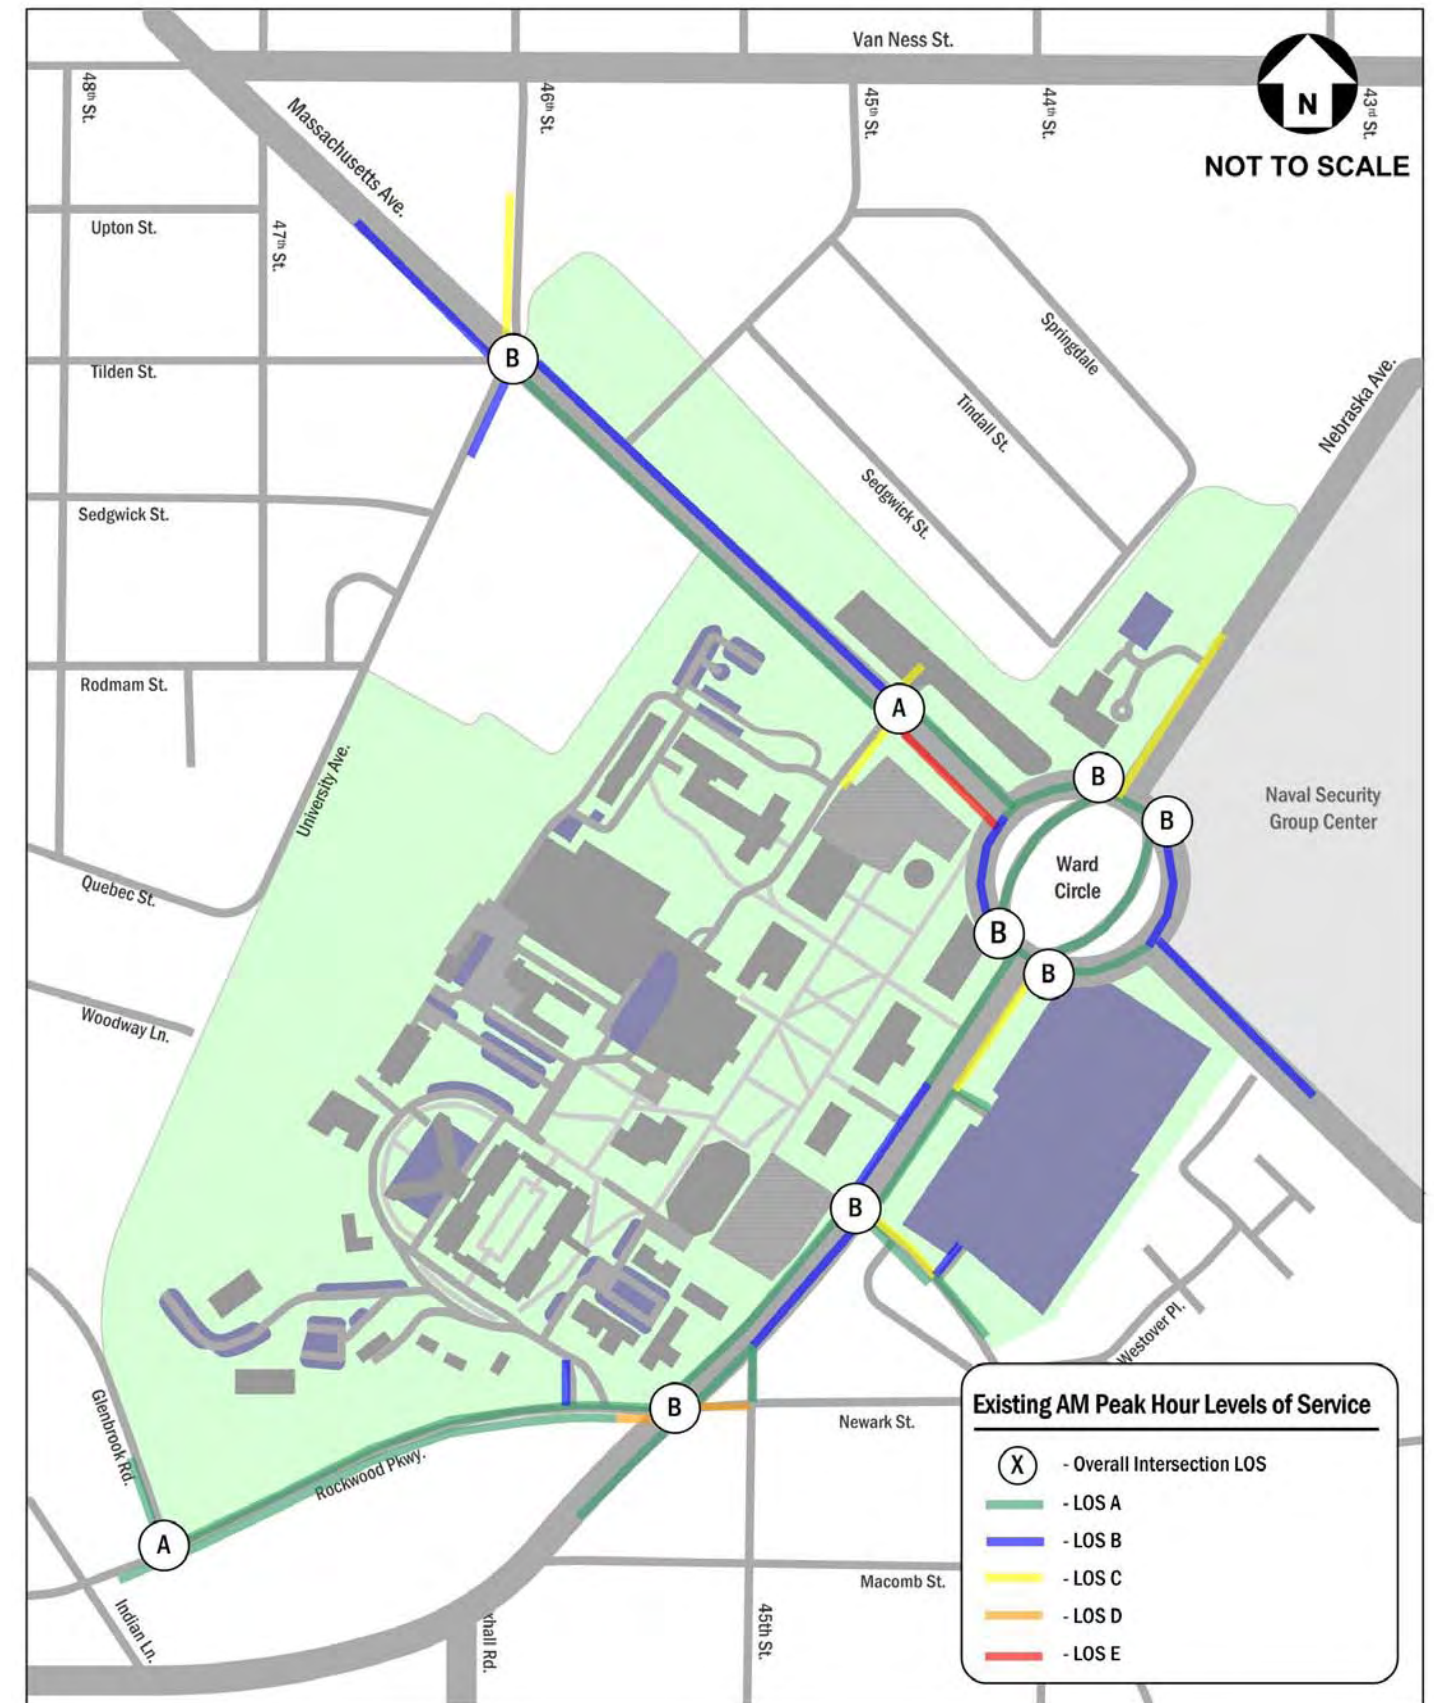
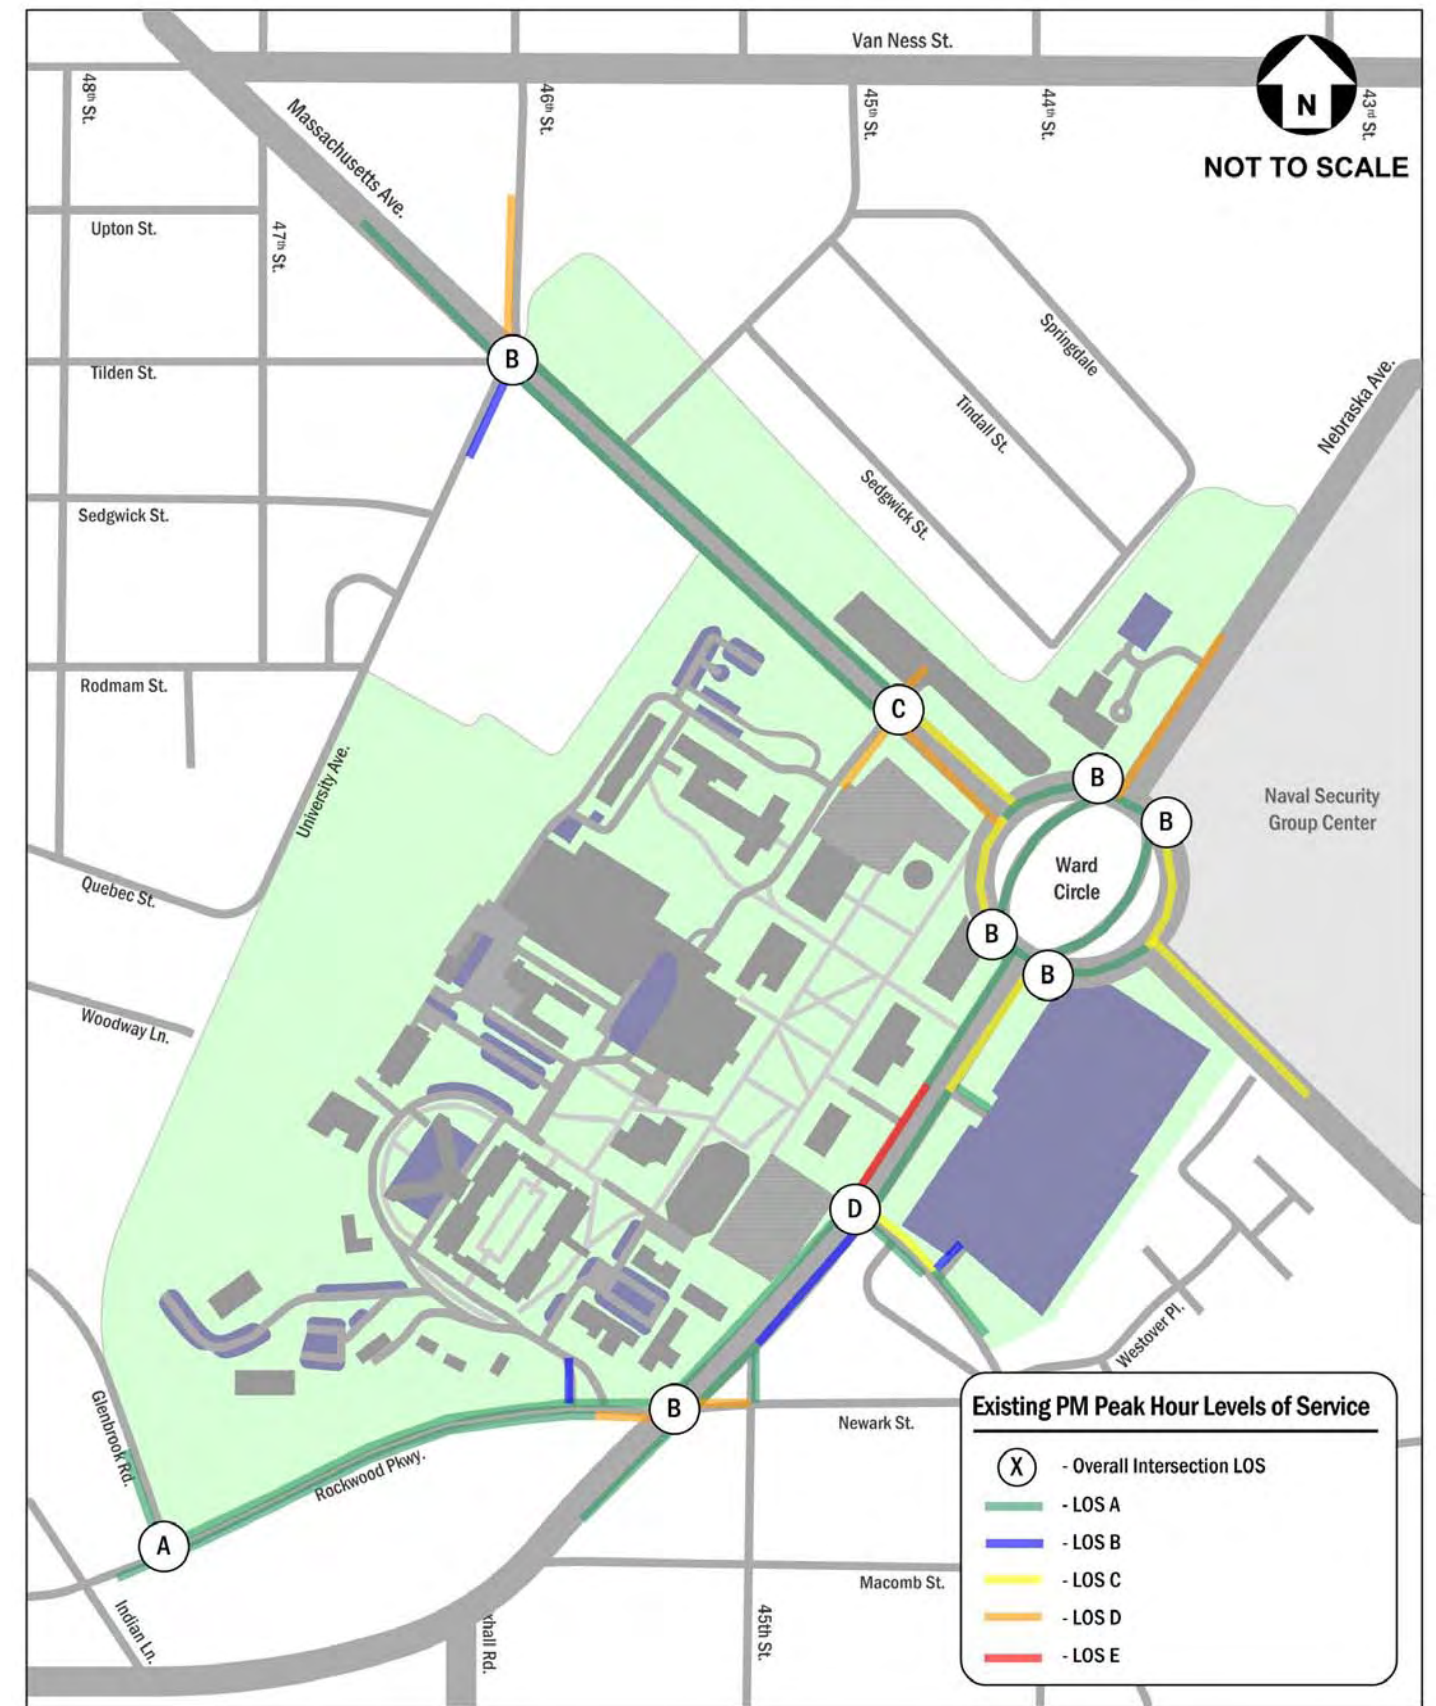
Figure 13: AM Peak Hour Levels of Service

The capacity analyses results indicate that all study area intersections operate at acceptable levels of service during both the morning and afternoon peak hours. Figure 13 and Figure 15 present the existing capacity analysis results, as well as traffic observations recorded in the field. Detailed results and observations can be found in Appendix B “CAPACTIY ANALYSIS”.

Existing conditions capacity analyses was performed to determine the existing Levels of Service (LOS) for the AM and PM peak hours for the study intersections. The existing LOS capacity analyses were based on: (1) the existing lane use and traffic controls; (2) the peak hour turning movement volumes; and (3) the *Highway Capacity Manual 2000* (HCM) methodologies (using Synchro 7 software).

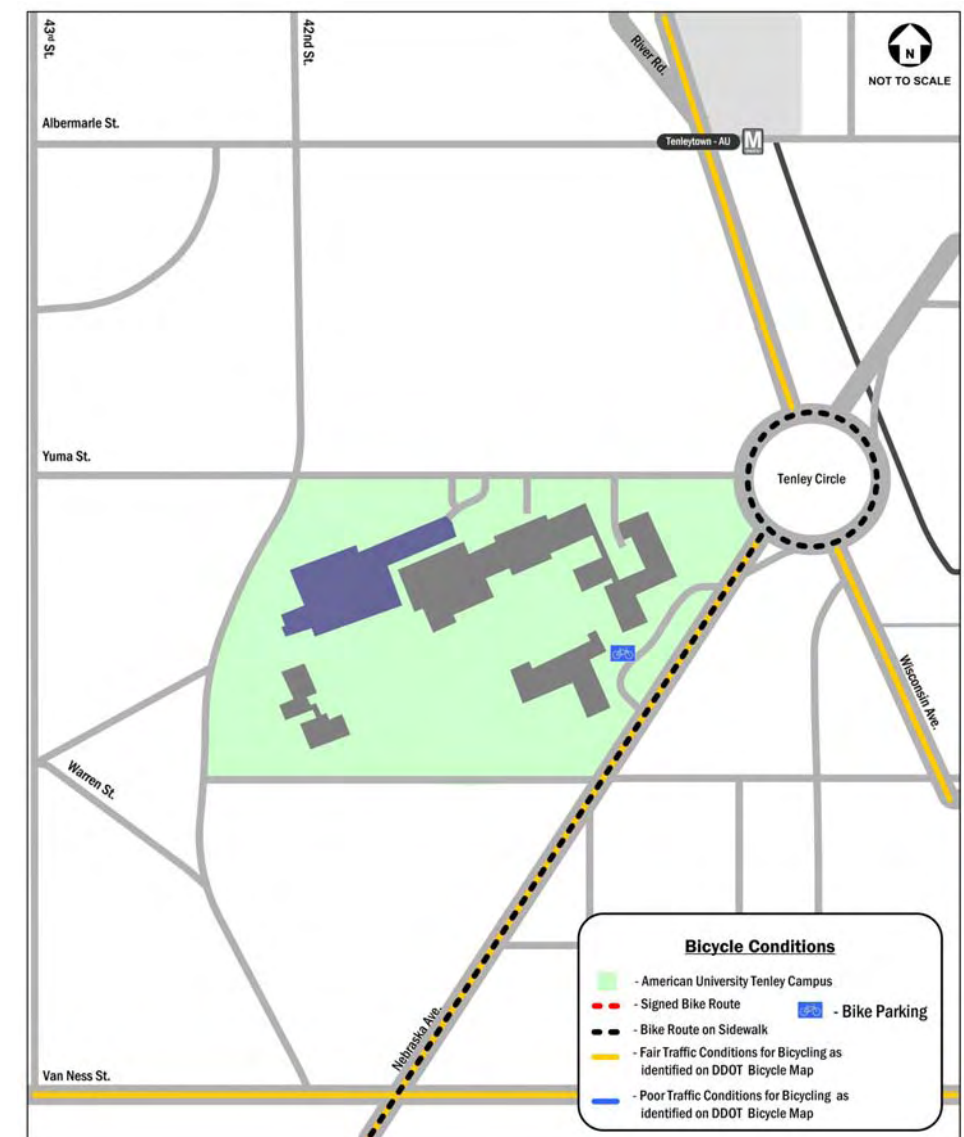
Figure 17: Bicycle Facilities at Tenley Campus

The District Department of Transportation (DDOT) indicates that bicyclist use the sidewalk on Nebraska Avenue and at Tenley Circle, but that an experienced bicyclist will feel conformable riding on-street on Wisconsin Avenue and nearby local streets (DDOT, January 2008). The 2005 DDOT Bicycle Master Plan recommends creating multi-use trails along Nebraska which would improve bicycling conditions between the Tenley campus and main campus.

The newly created DC bike-sharing system, DC Smart Bike, does not have any locations near the Tenley campus nor do they have any plans to expand near it in the near future. Even if bike sharing stations were not implemented in neighborhoods external to AU, establishing a station on each of the three AU campuses would provide another option for inter-campus travel.

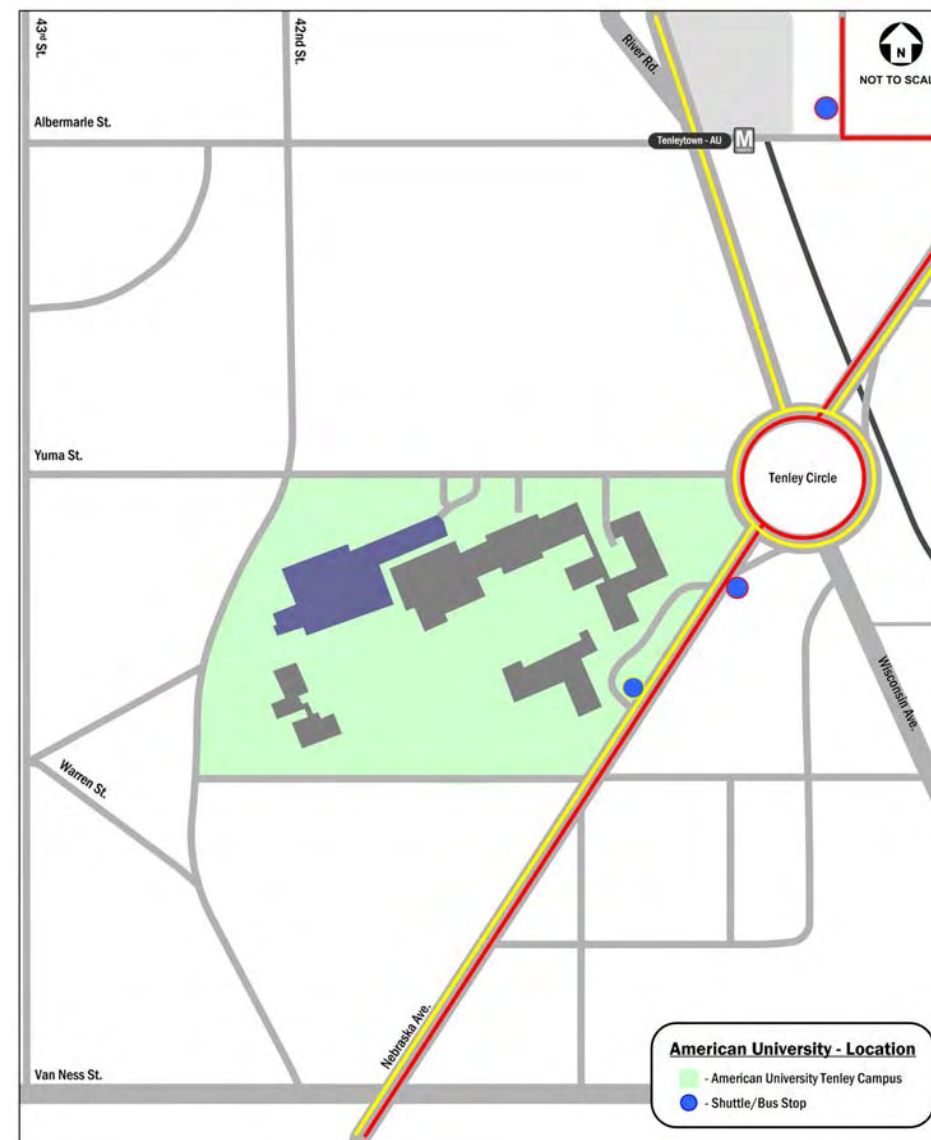
Figure 18: AU Shuttles Routes at Tenley Campus

AU provides free shuttle service between the main campus and the Tenley campus, Washington College of Law and Tenleytown/AU Metro station. There are two stops at the Tenley campus. One serves those traveling westbound between the Tenley campus and Tenley-AU Metrorail station and one traveling eastbound that links the Tenley and Main campus. Figure 18 identifies shuttle routes and stop locations.

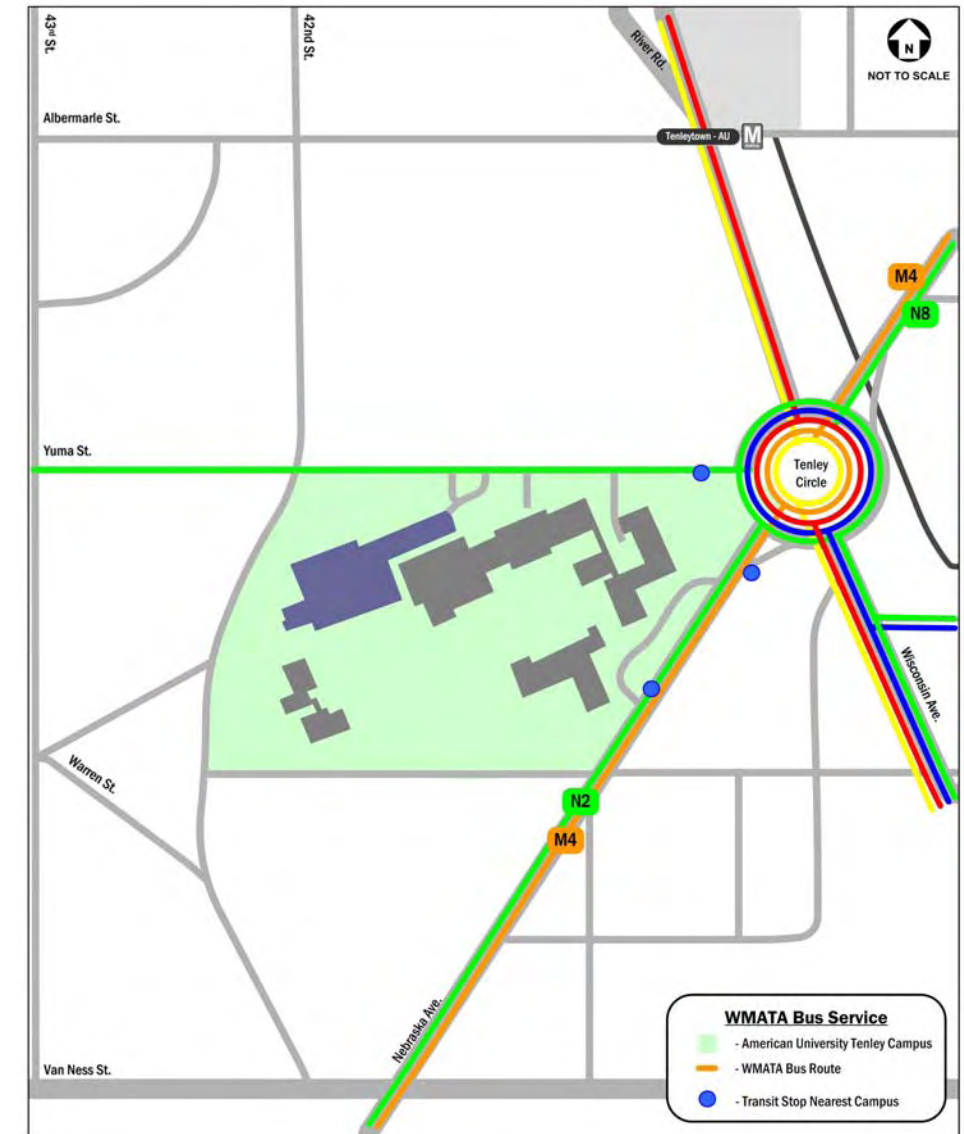
Figure 19: WMATA Bus Service at Tenley Campus

The AU Tenley campus is directly served by Metrobus and is within walking distance of the Red Line Tenley-AU Metrorail Station. Figure 19 identifies Metrobus routes and stops and the nearest Metrorail station location that serve AU. Transit connects the campus and destinations throughout the District and Maryland.

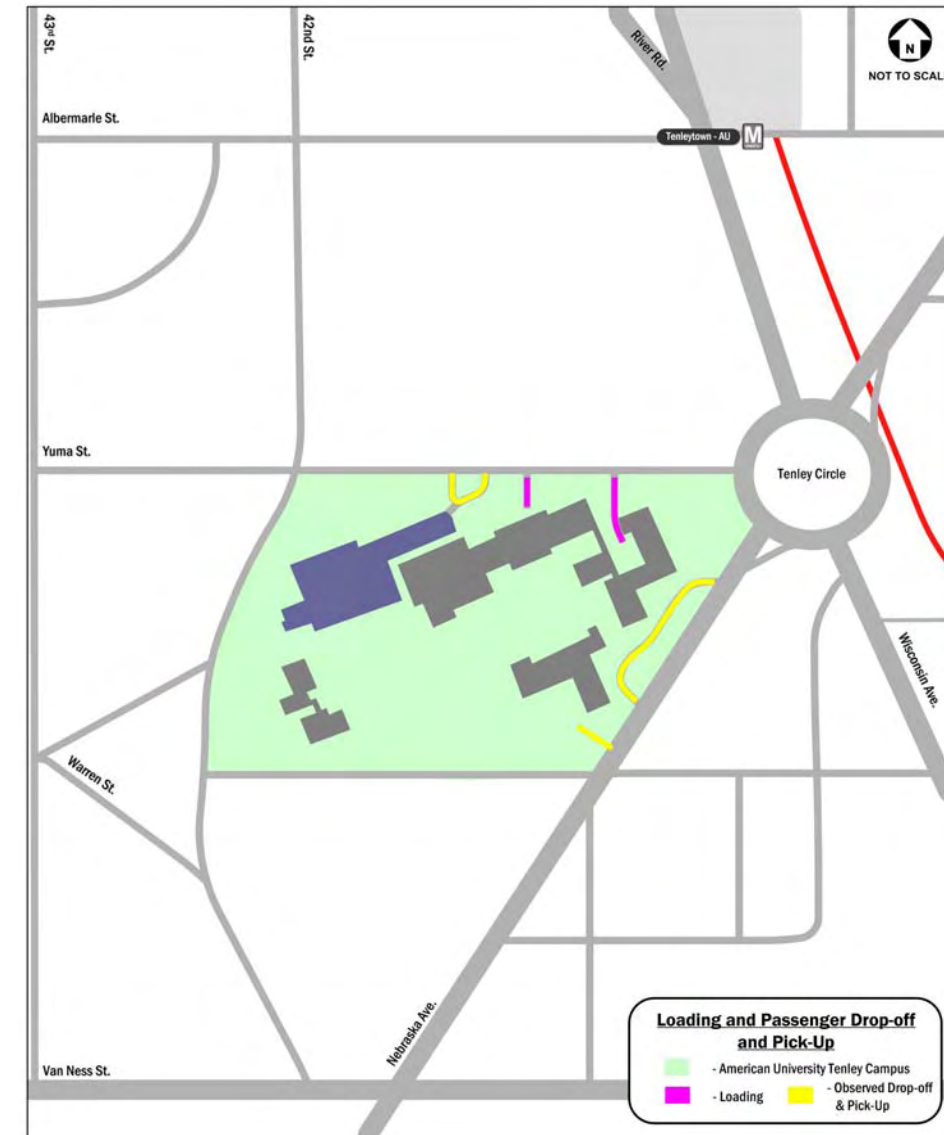
Figure 20: Tenley Campus Loading & Pick-up Activity

Passenger drop-off and pick-up activity occurs throughout the campus. Figure 20 identifies the most commonly used locations for passenger drop-off and pick-up. There are no designated drop-off or pick-up locations on campus or areas where this activity is easily accommodated.

Shipping and receiving facilities are located along Yuma Street. Figure 20 identifies the location of shipping and receiving facilities.
