AMERICAN UNIVERSITY

Transportation Existing Conditions Assessment for 2011 Master Plan Update

GOROVE/SLADE ASSOCIATES, INC.
Transportation Planners and Engineers

July 2009

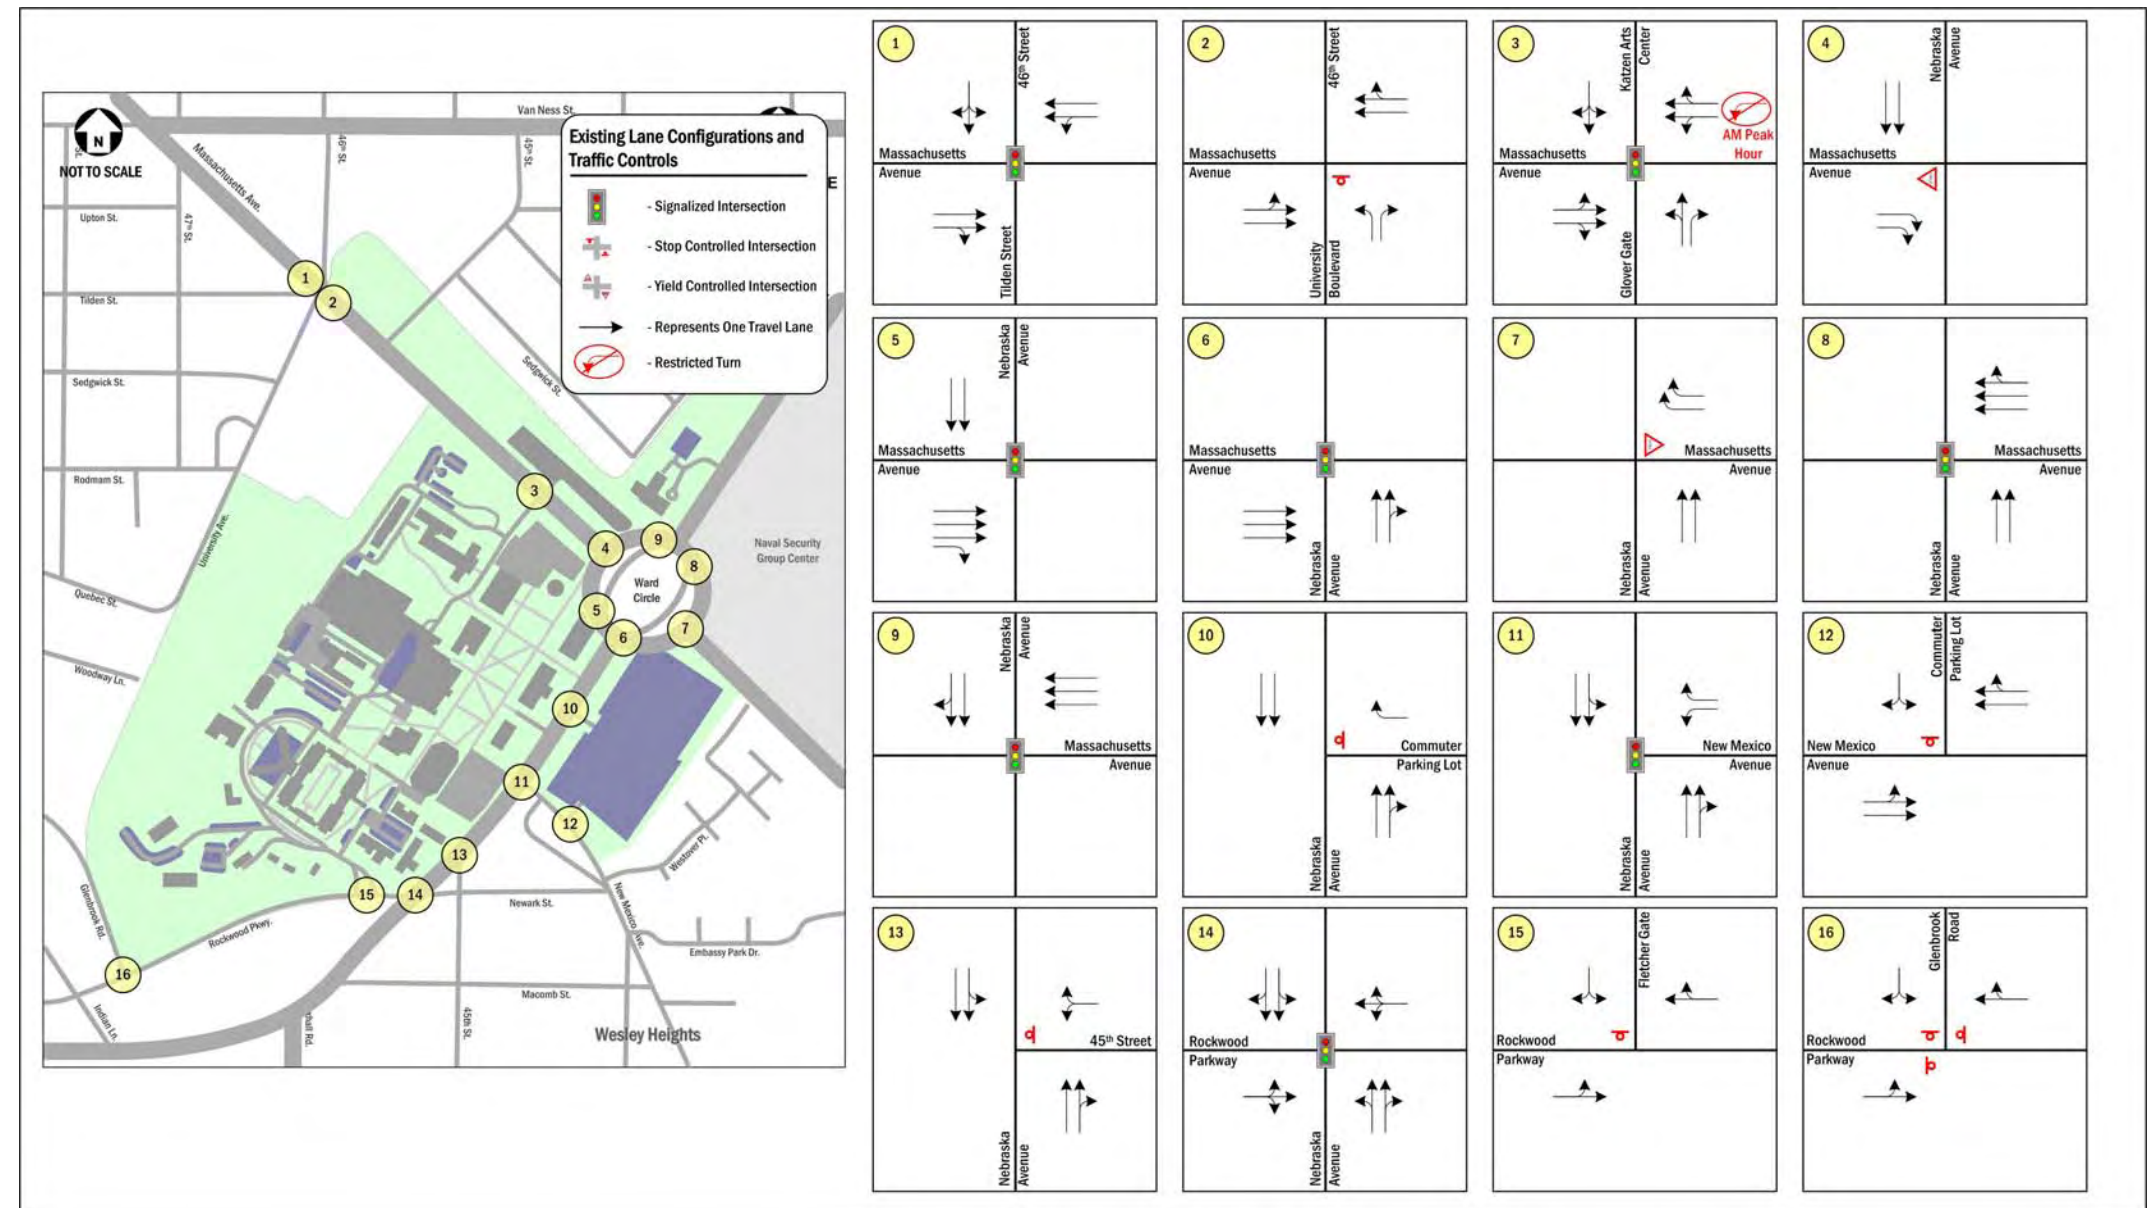
Figure 22: Existing Lane Configurations and Traffic Controls

West of the American University Tenley campus, 42nd Street is a 2-lane roadway. The roadway is classified by DDOT as a collector, with an average daily traffic of 6,600 vehicles. Within the limits of the study area, 42nd Street runs from Yuma Street to Warren Street. The posted speed limit in the vicinity of the site is 25 mph.

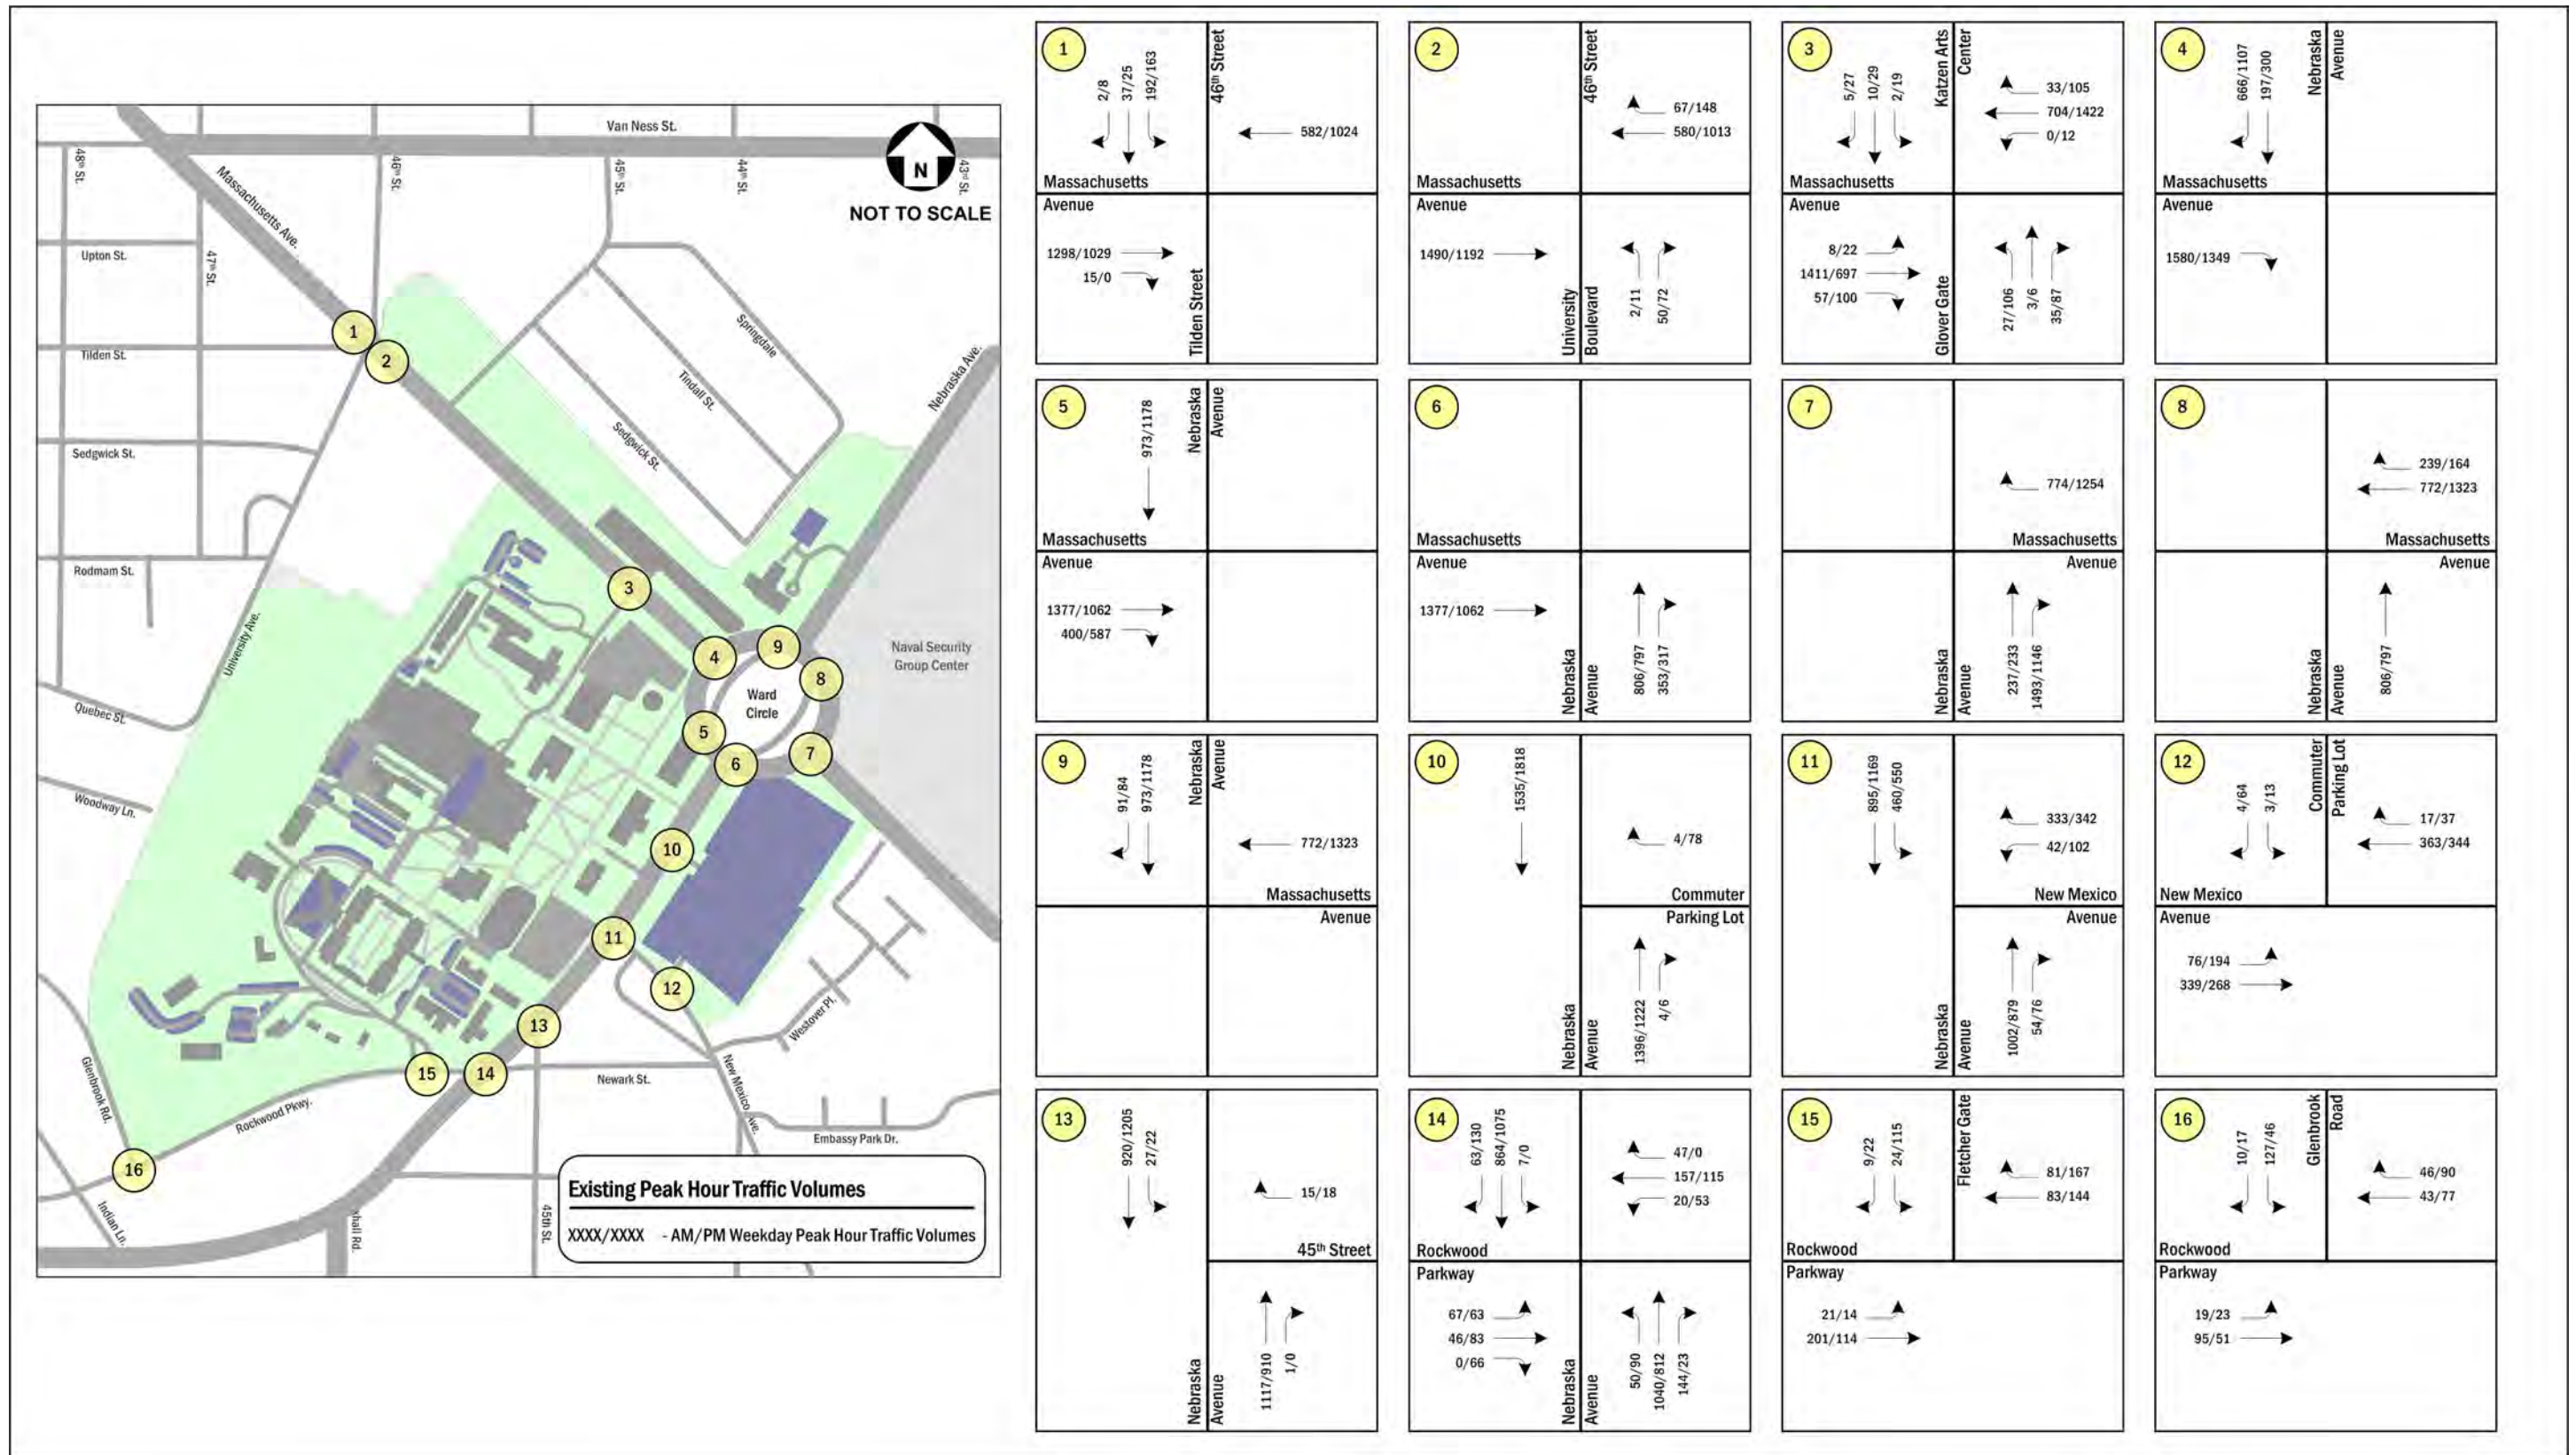
Figure 23: Existing Peak Hour Traffic Volumes

Traffic counts were conducted at the key study intersections between the hours of 6:00 to 9:00 AM and 3:00 to 7:00 PM on typical weekdays. The results of the traffic counts are included in the Technical Appendix. The morning and afternoon peak hours for the system of intersections being studied occur between 7:45 and 8:45 AM and 5:00 and 6:00 PM, respectively. Peak hour traffic volumes are shown on Figure 23.
